REPLACING FUEL INJECTORS ON A FIAT BRAVA

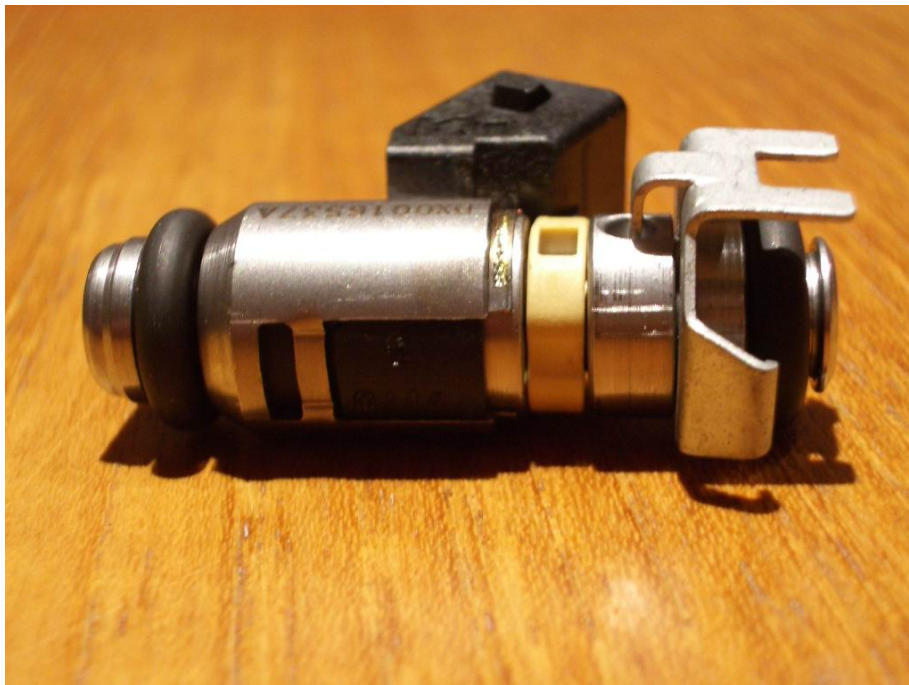
Figure 1 Fuel Injector Fiat Part 0071718998

- 12 Now the faulty injector/s can be pulled out from the rail by pulling off the retaining clip and unplugging the electrical connection.
- 13 Replacing all ‘O’ seals and gaskets disturbed in the procedure, is recommended by the manufacturer. They should at least be checked. The ‘O’ seals on the fuel injectors may be lubricated with light oil to assist re-insertion.

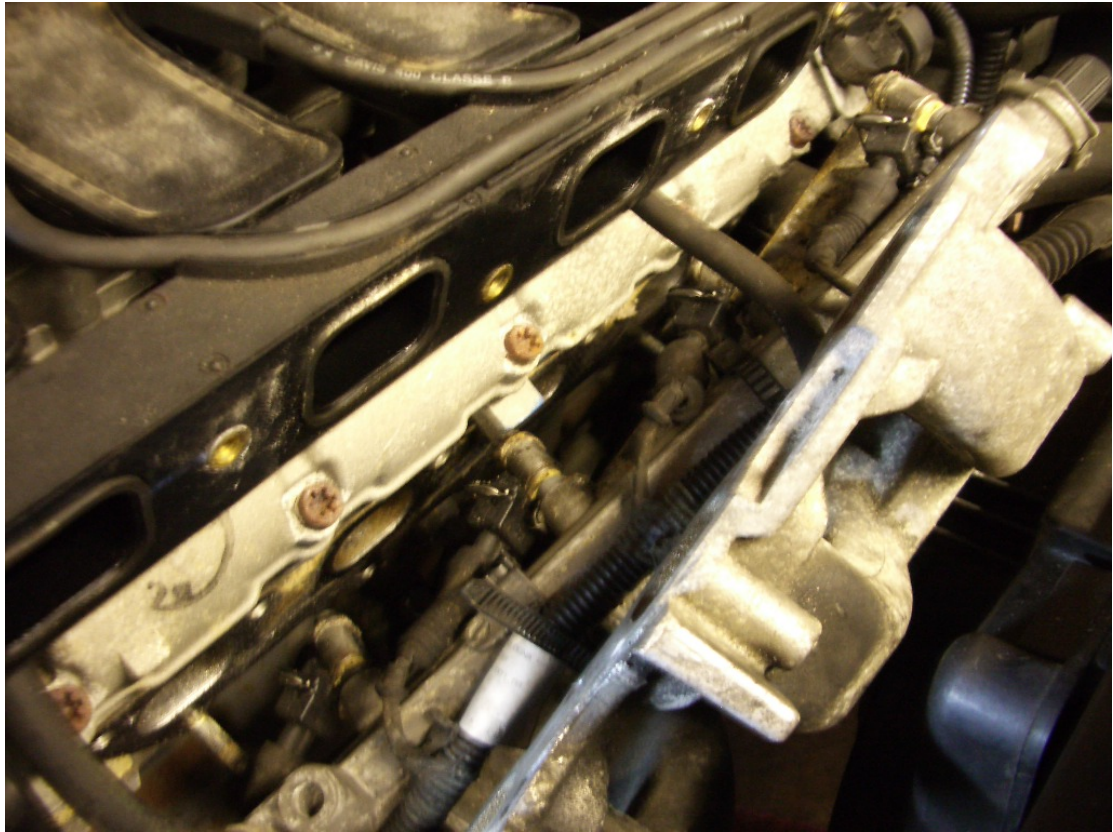
Figure 2 Removing the Lower Manifold exposing the detached fuel rail

- 7 The lower inlet manifold must be removed completely. Gradually release and extract the four Torx bolts holding the lower to the upper manifold, and bolts holding the plug shield on the right hand side.

- 9 Before finally removing the lower manifold, remove the two Philips head screws holding the fuel rail assembly to the inlet manifold.
- 10 Remove the lower manifold and pull the fuel rail assembly including injectors from the engine. There will be some fuel spillage – have a cloth ready

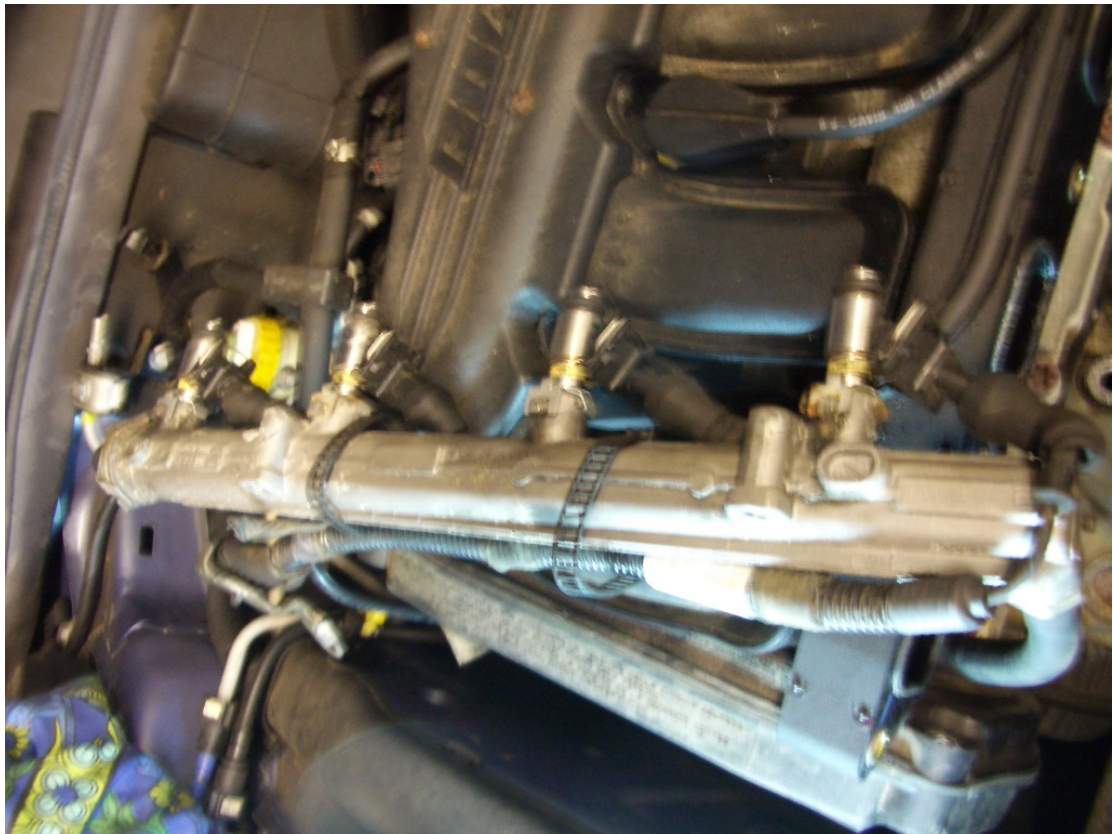
Figure 3 Fuel rail with injectors available for replacement
